## BROBERG Red Bohus

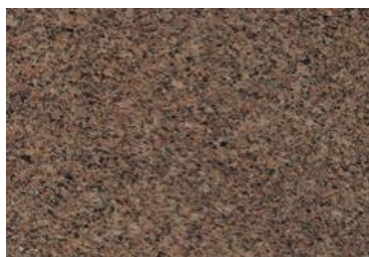
Polished

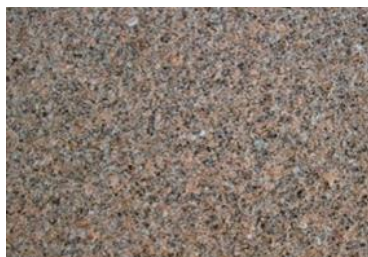
Flamed

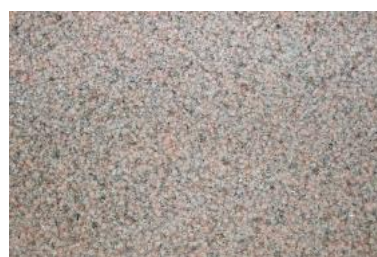
Bush-hammered
